Safety Inspection Report

Annual Inspection

King George V Recreation Ground

Hurstbourne Tarrant Parish Council

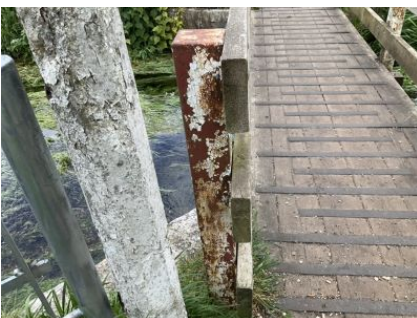
Access - Bridge

Paintwork is in poor condition.

De-scale back to good base material and coat with lead free paint, using appropriate precautions. Repairs may be necessary where corrosion is severe.

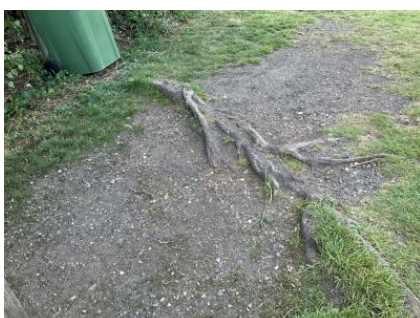
Trip points on the surface.

Tree roots becoming trip hazard. Add more gravel/earth to eliminate risk.

Make level.

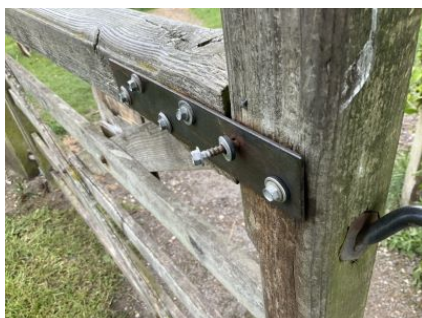
Fixtures loose or missing.

Tighten.

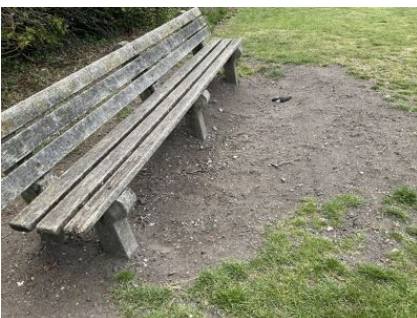
Ground erosion present.

Repair the worn areas.

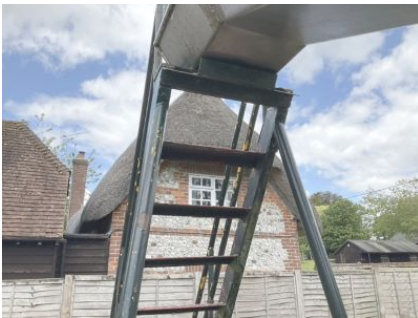
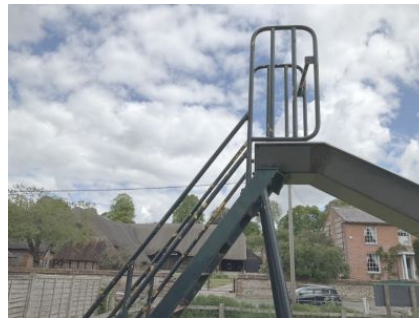
There is a head entrapment.

The unit was installed prior to the publication of the current standards. There is no requirement to make retrospective changes.

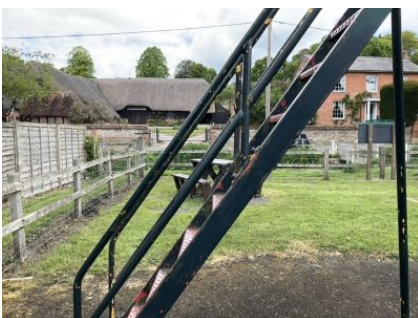
Hand rail height is below the minimum permitted of not less than 600 mm above the standing surface.

The unit was installed prior to the publication of the current standards. There is no requirement to make retrospective changes.

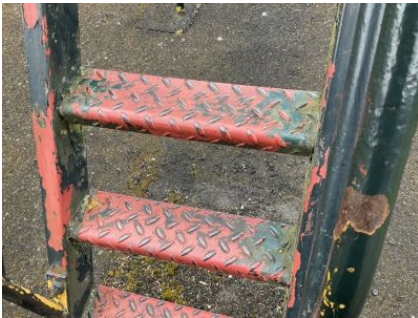
The depth of stair tread is either less than 110 mm or the projection is less than 140 mm, or both.

The unit was installed prior to the publication of the current standards. There is no requirement to make retrospective changes.

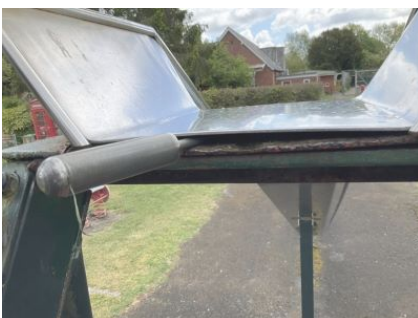
Finger entrapment.

Eliminate the entrapment.

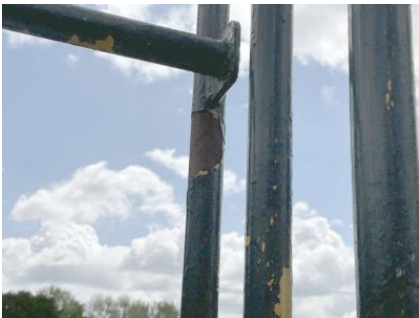
Item has corrosion.

Treat and repair.

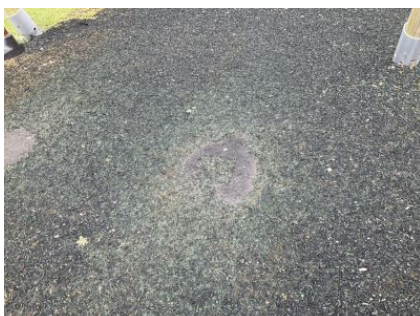
Surface is wearing.

Monitor for significant deterioration and rectify when necessary.

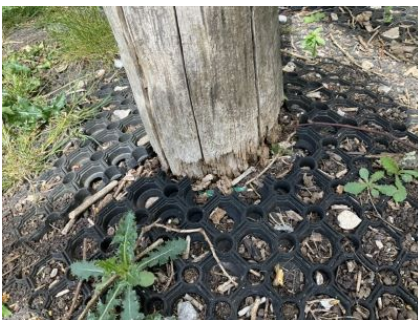
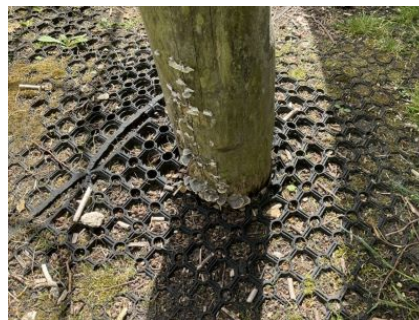
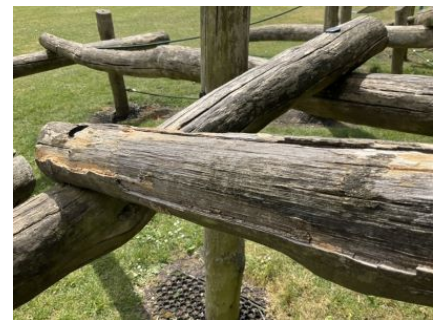
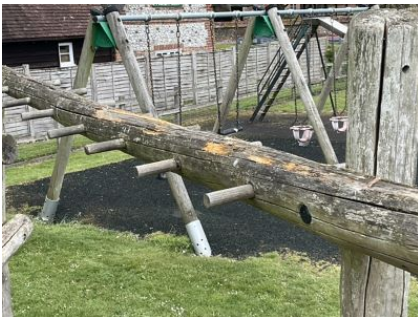
Timber is decayed.

Many posts are showing signs of decay. Replace worst affected and continue to monitor the others.

Replace affected parts.

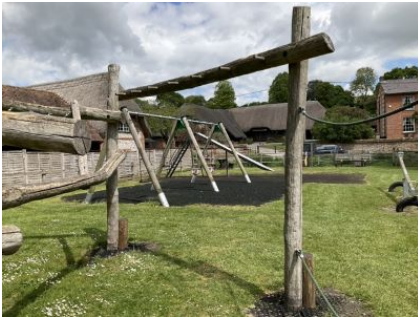
Overhead ladders and rings provide significant play value and benefits to children, and with it the risk of falling. Ensuring the surface remains in good condition will help to keep the correct balance between benefits and risk.

Some pegs are missing. Replace.

The protective surface under all bars and rings must be kept in good condition., Read the notes for further action.

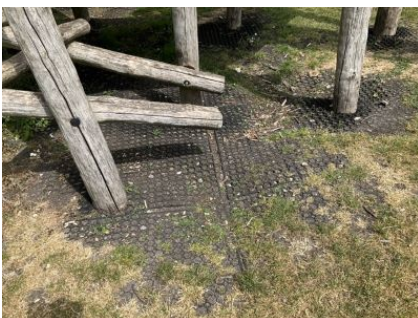
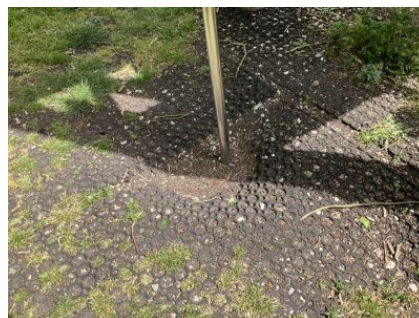
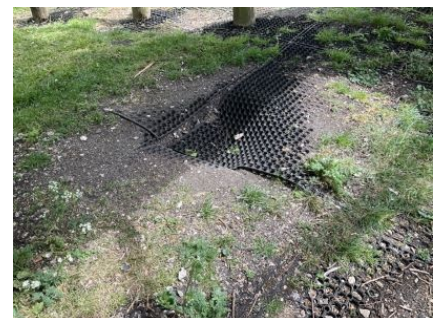
Surface is wearing.

Repair.

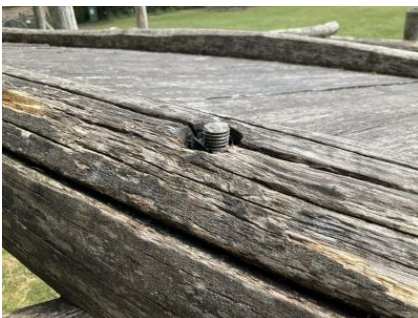
Cap missing.

Replace.

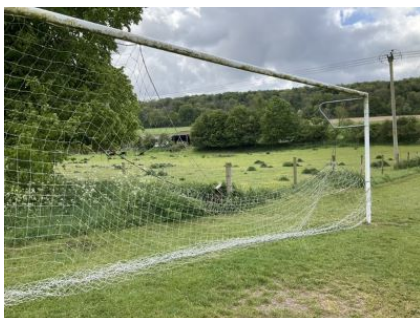
Minor repairs are needed.

Repair.

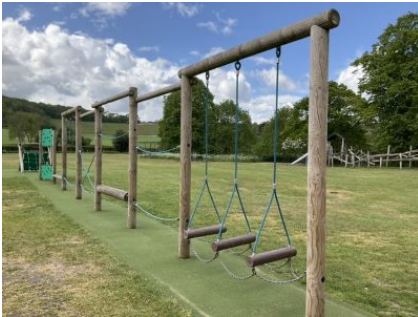
This equipment relies on one post for its stability. Special attention should be paid to maintenance (e.g. by monitoring degradation) and if necessary decommissioning the item before the end of its operating life. This is a requirement of the British Standard.

Routinely check for decay.

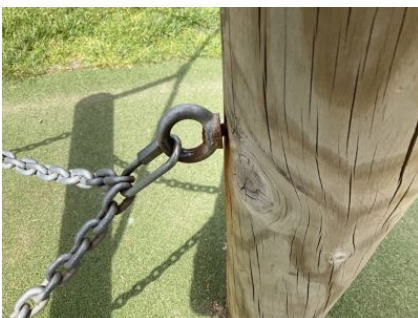
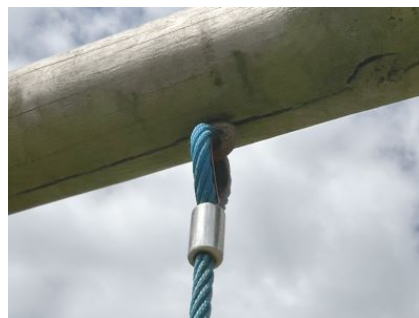
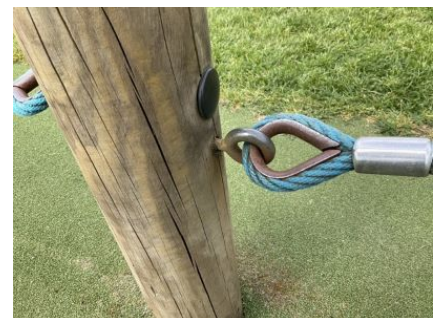
Bolt(s) loose.

Tighten.

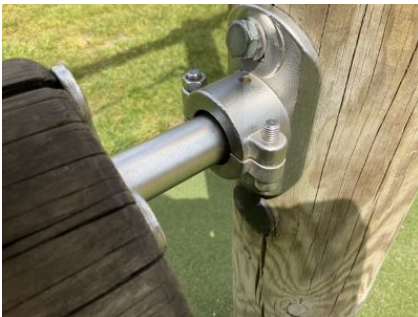
Fixtures loose or missing.

Nut missing.

Replace.

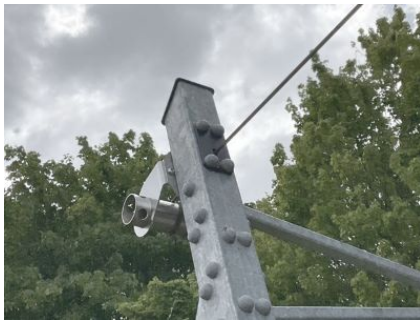
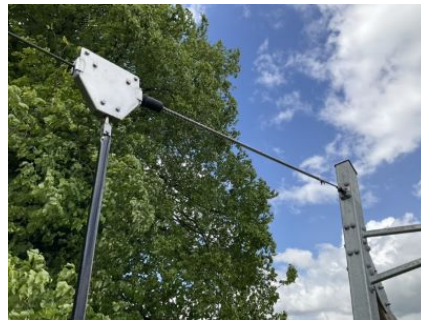
Cables have been known to fail under load due to wear and corrosion. This is generally where the cable enters into a tube, top bar, sleeve or similar, where the wire is in contact and wears and frays over time, but can happen anywhere on the cable. It is important to inspect any hidden parts at least annually. Damaged cables require replacement. This cannot be determined during an annual inspection, and is excluded from our inspection. This can lead to a high risk if no action is taken. Refer to the manufacturer's instructions to ensure the correct check is carried out.

Conduct an appropriate dismantling inspection according to the manufacturer's instructions, and at least annually. The trolley mechanism can be checked at the same time.

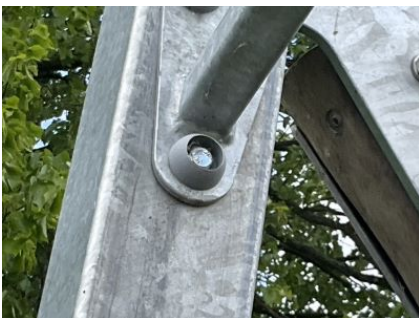
Cap missing.

Replace.
