Safety Inspection Report

Annual Inspection

King George V Recreation Ground

Hurstbourne Tarrant Parish Council

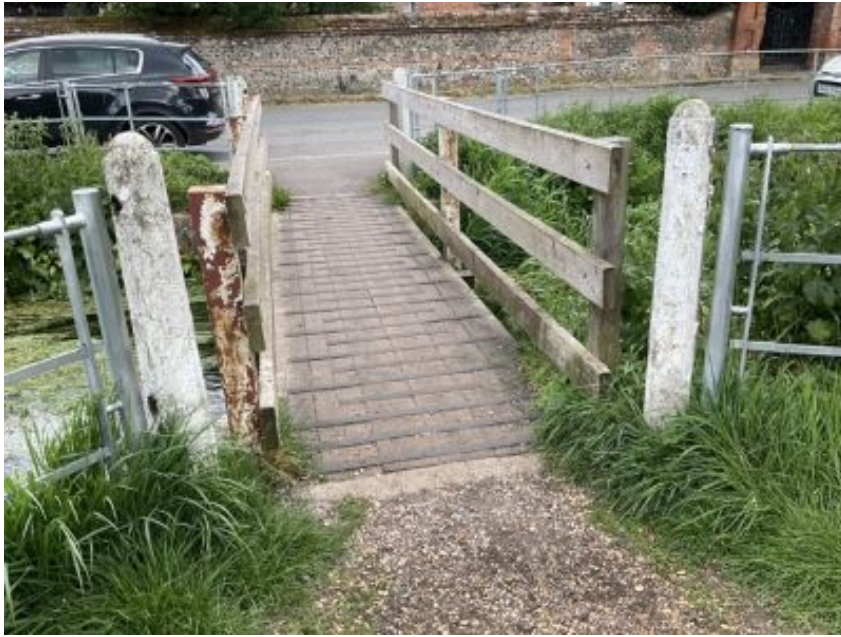
Access - Bridge

Paintwork is in poor condition.

De-scale back to good base material and coat with lead free paint, using appropriate precautions. Repairs may be necessary where corrosion is severe.

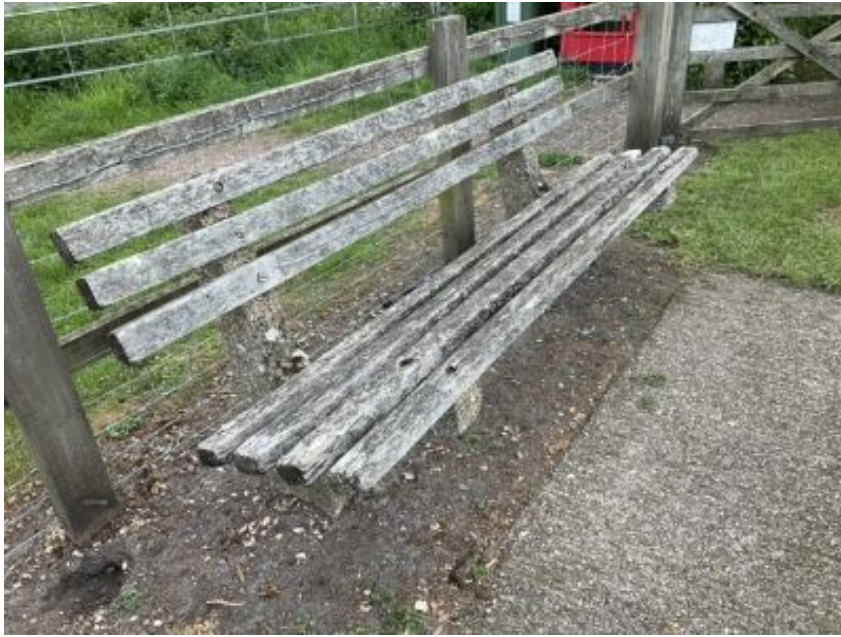
Seating

Description	Tasks	Risk score
Ground erosion present.	Repair the worn areas.

Repair the worn areas.

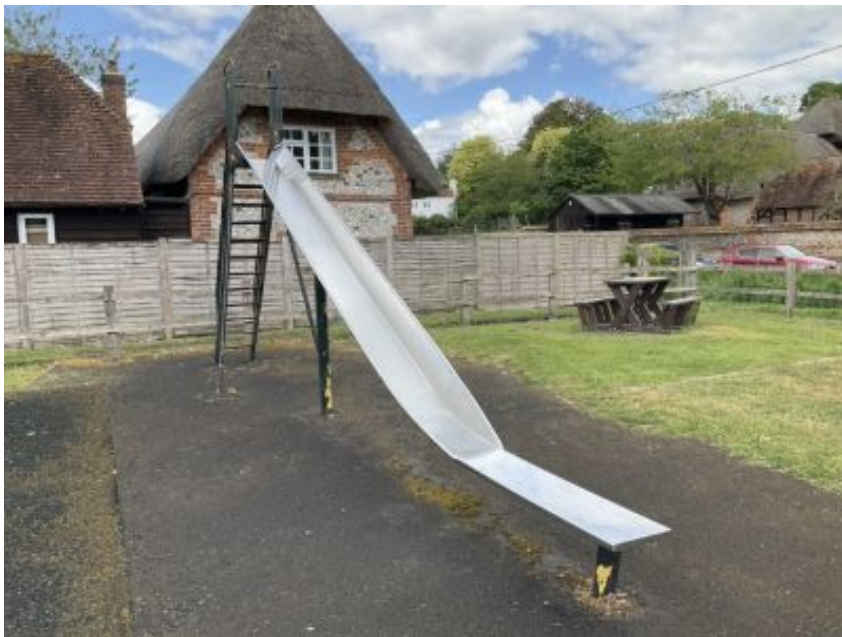
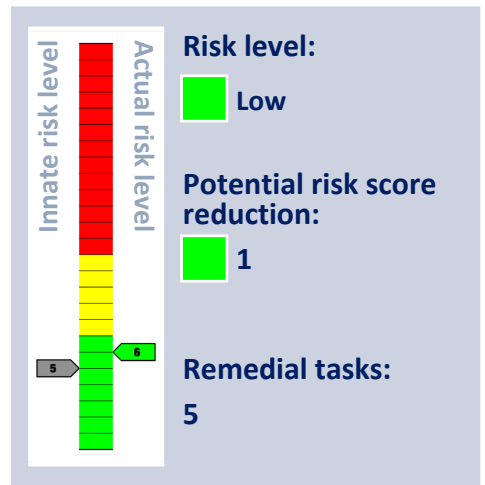
Slide

1. Item has corrosion.

Item has corrosion.

Treat and repair.

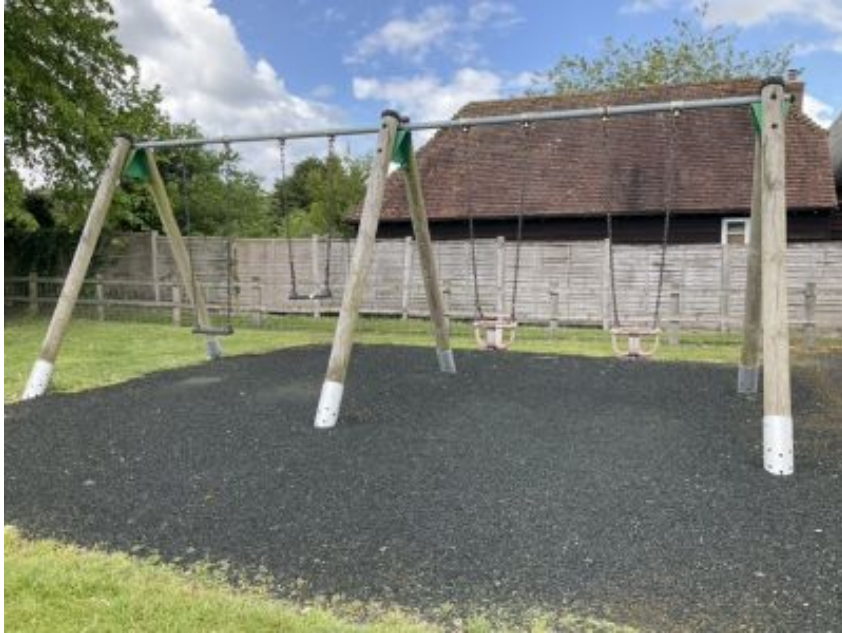
Swing - Mixed - 2 Bay 2 Junior 2 Toddler Seat

3
Chains are twisted.	Untwist the chains to prolong their life and check for wear.

Surface is wearing.

Monitor for significant deterioration and rectify when necessary.

Untwist the chains to prolong their life and check for wear.

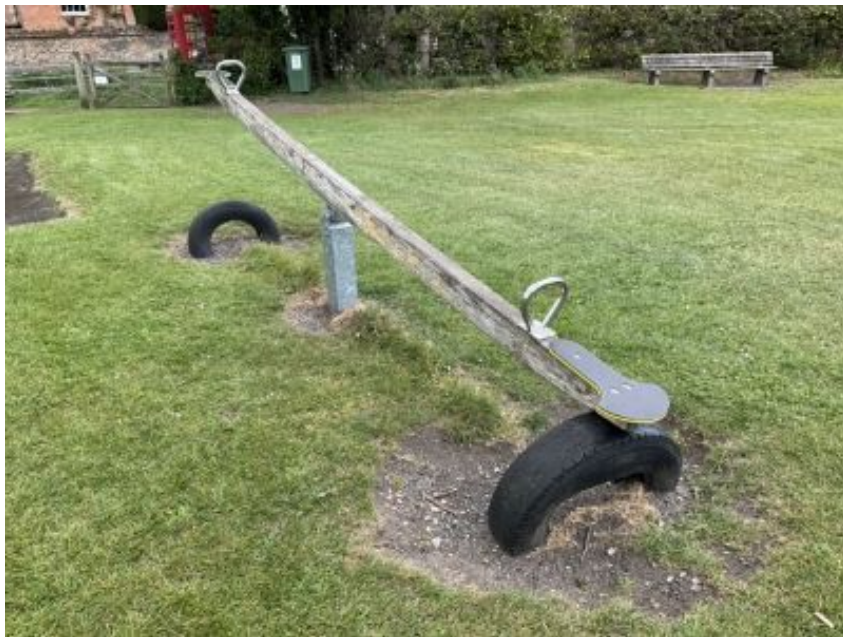
Rocker - Seesaw - Beam

Description	Tasks	Risk score
Ground erosion present.	Consider adding grass matting to prevent wear.

Consider adding grass matting to prevent wear.

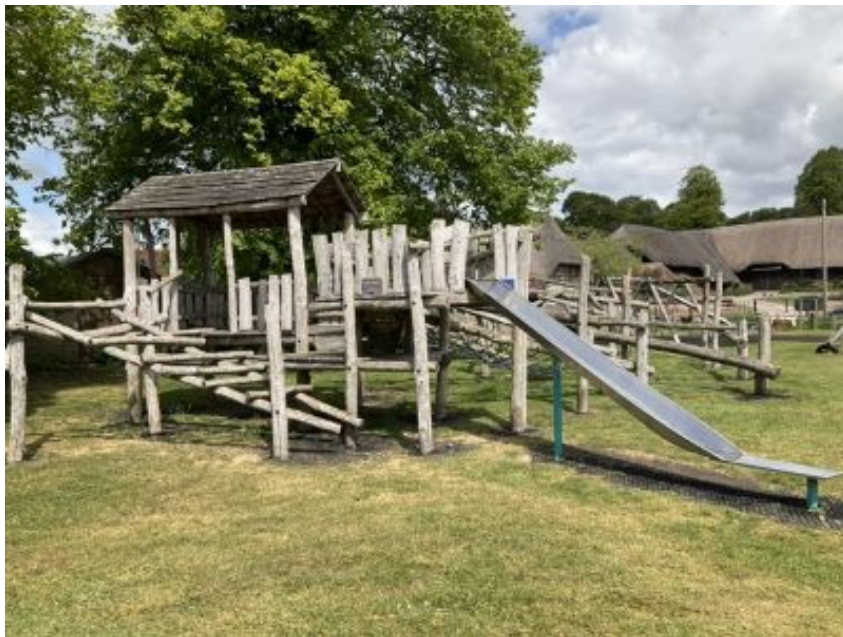
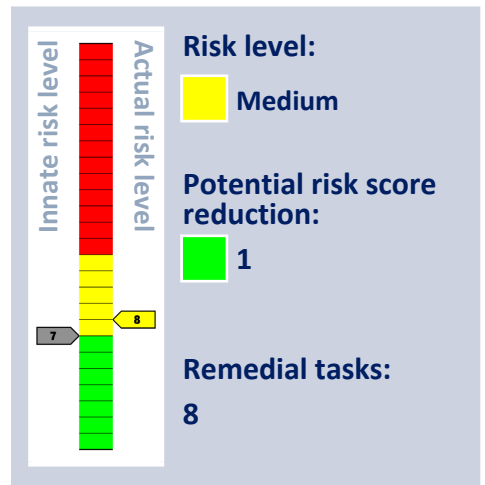
Multiplay - Climber

1. Timber is decayed.
2. Overhead ladders and rings provide significant play value and benefits to children, and with it the risk of falling. Ensuring the surface remains in good condition will help to keep the correct balance between benefits and risk.
3. Surface is wearing.
4. There are natural splits / shakes in the timbers.
5. Cap missing.

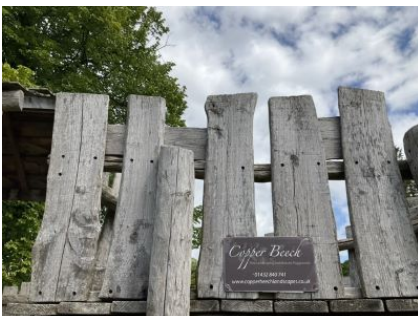
Timber is decayed.

Many posts are showing signs of decay. Replace worst affected and continue to monitor the others.

Replace affected parts.

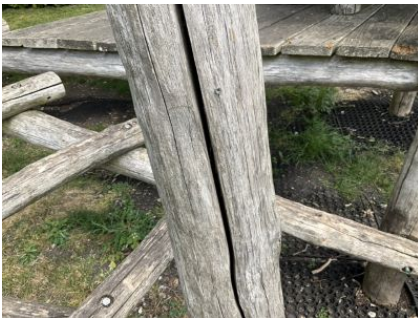
Cap missing.

Replace.

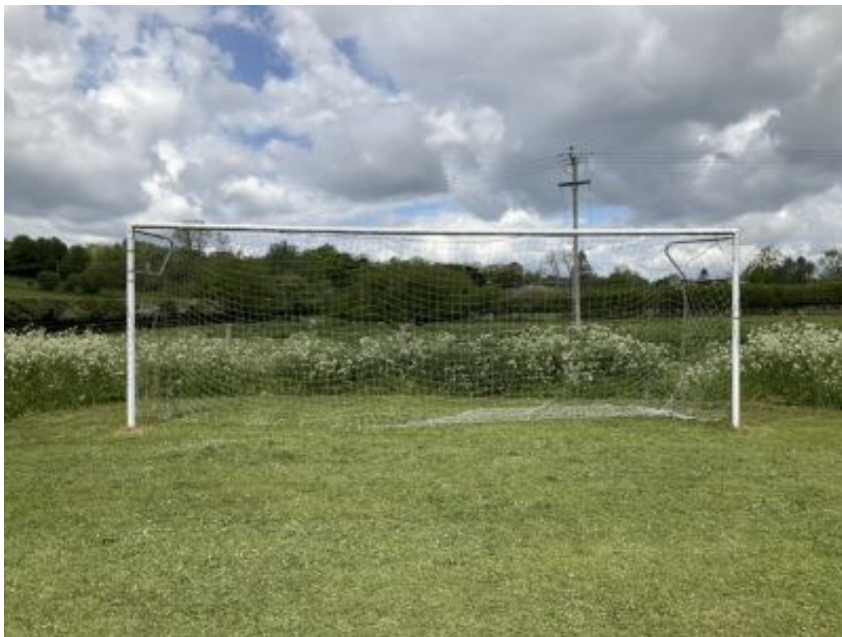
Goal Post - Football - Full Size

Minor repairs are needed.

Repair.

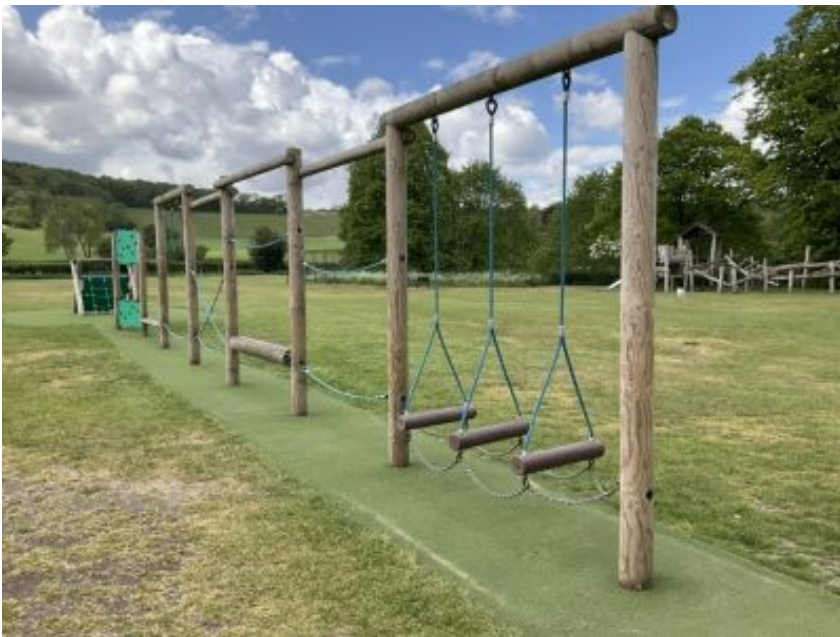
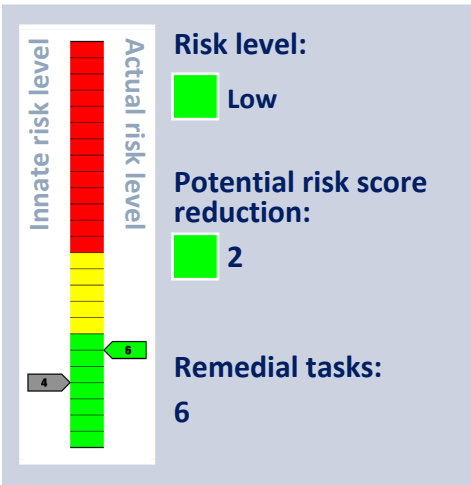
Agility - Trim Trail

This equipment relies on one post for its stability. Special attention should be paid to maintenance (e.g. by monitoring degradation) and if necessary decommissioning the item before the end of its operating life. This is a requirement of the British Standard.

Bolt(s) loose.

Routinely check for decay.

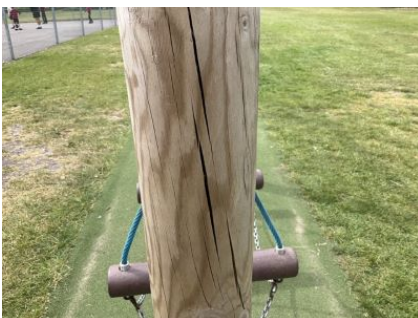
Fixtures loose or missing.

Nut missing.

Replace.

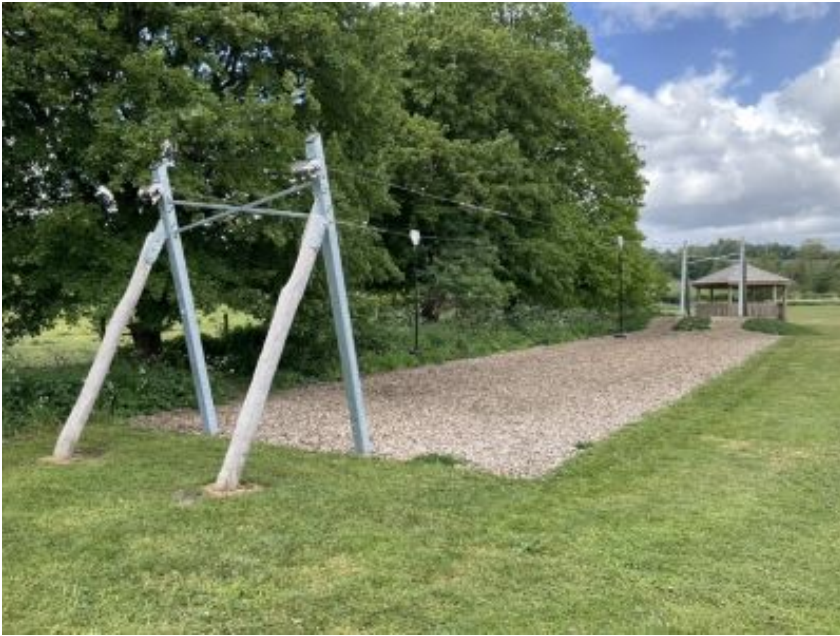
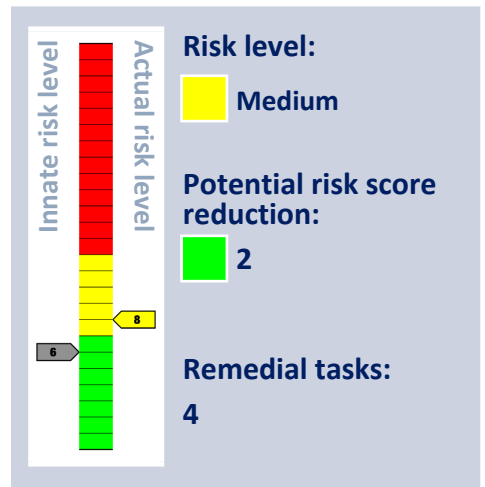
Cableway

Cables have been known to fail under load due to wear and corrosion. This is generally where the cable enters into a tube, top bar, sleeve or similar, where the wire is in contact and wears and frays over time, but can happen anywhere on the cable. It is important to inspect any hidden parts at least annually. Damaged cables require replacement. This cannot be determined during an annual inspection, and is excluded from our inspection. This can lead to a high risk if no action is taken. Refer to the manufacturer's instructions to ensure the correct check is carried out.

Remove chain covers to inspect according to manufacturer's instructions, and replace the covers when done.

Consider adding grass matting to prevent wear.

Replace.
